EVALUATION OF SELECTED TREES AT

AT NORTHWEST UNIVERSITY

5520 108th Avenue NE
Kirkland, WA 98033

February 19, 2016

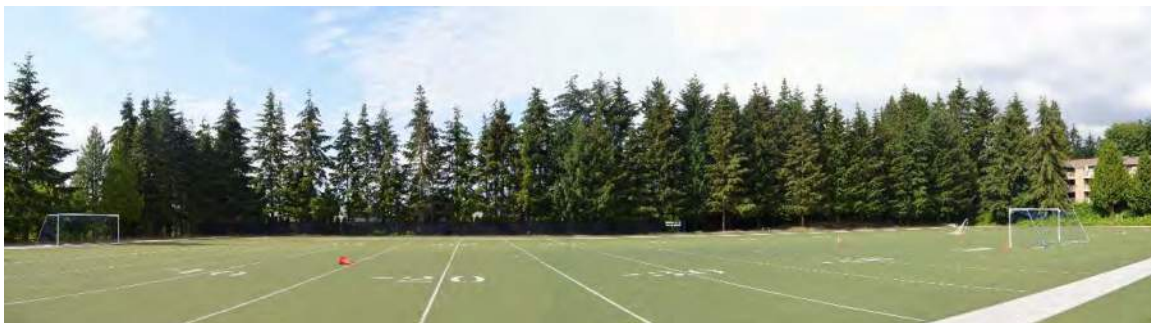
Photo # 1: A panoramic photos of the approximately 100 trees north of the athletic field.

This photo shows that this stand of trees is likely meeting the design intent of when the trees were planned and installed.

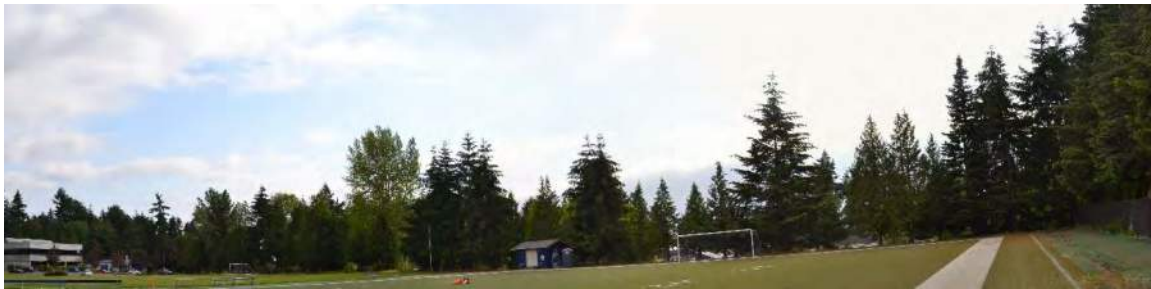
Photo # 3: A panoramic photo looking from near the NE corner of the athletic field at the row of trees on the west facing slope above the parking lots.

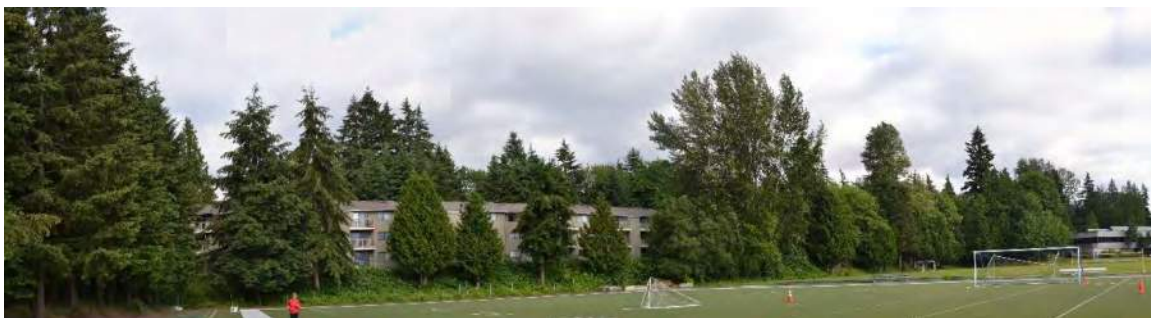
Photo # 4: A panoramic photo looking from near the north-central portion of the athletic field looking at the eastern property line and the row of trees.
